CALSPAN ON-SITE SCHOOL BUS/PEDESTRIAN ACCIDENT INVESTIGATION

CALSPAN CASE NO. 95-14/3

SCHOOL BUS: 1992 INTERNATIONAL CHASSIS/AM TRAN (WARD) BODY

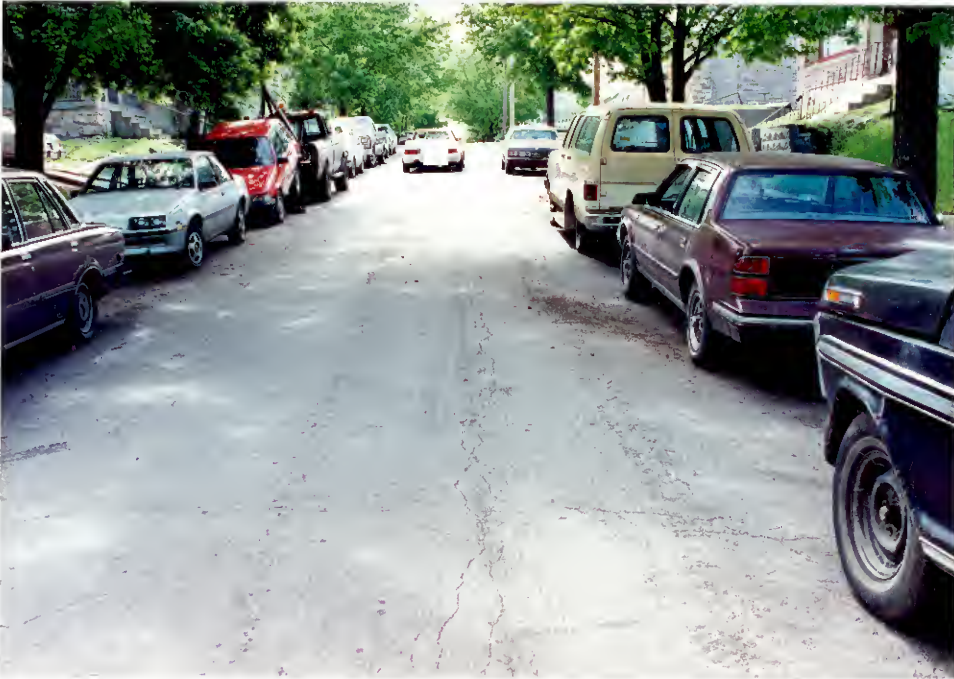
5. Bus continues forward in an easterly direction with pedestrian running/dragged along right side of bus.

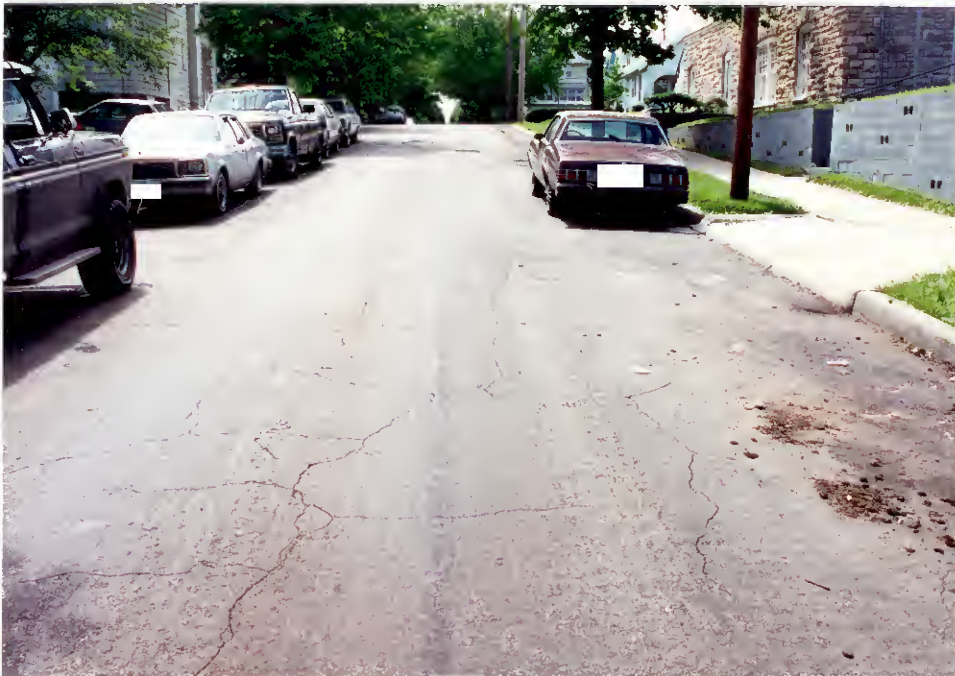
6. Area where pedestrian was run over by the right rear tires of the bus.

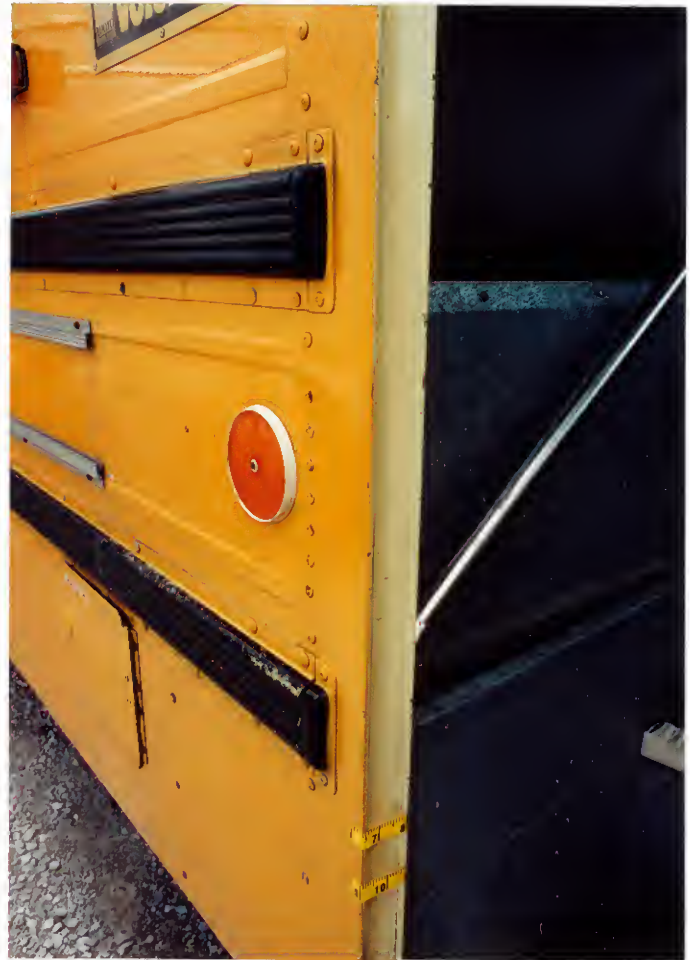
22. V-channel along right B-pillar.

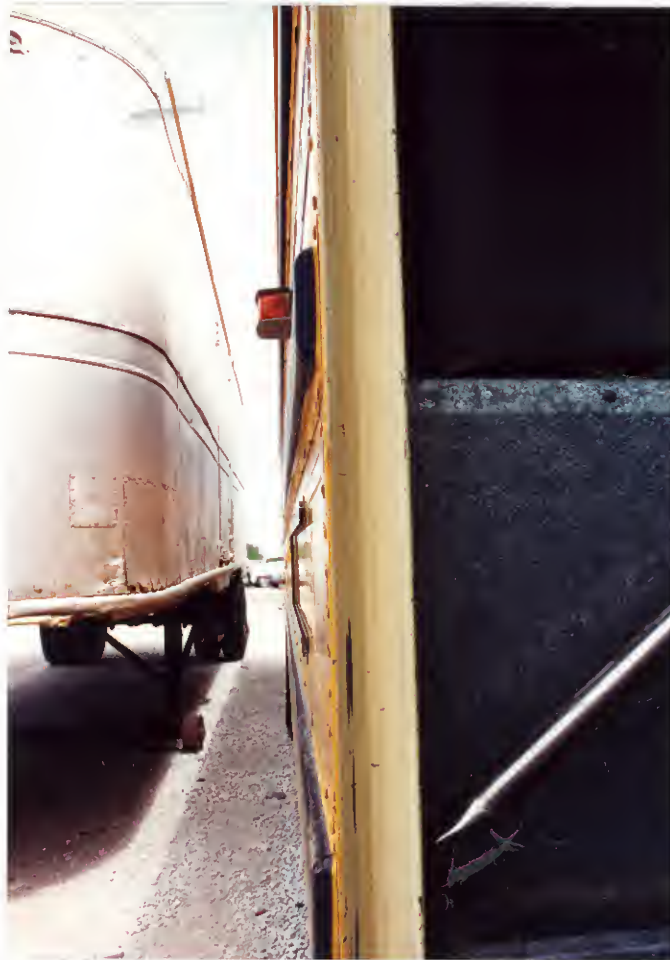
23. Additional view of the V-channel.

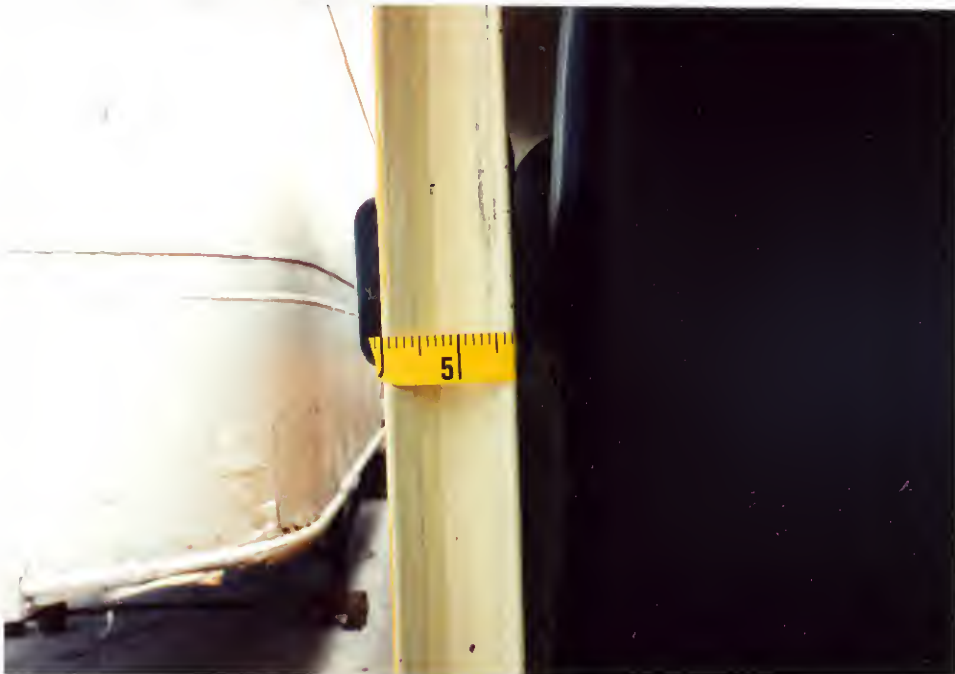
24. Close-up view of the V-channel.

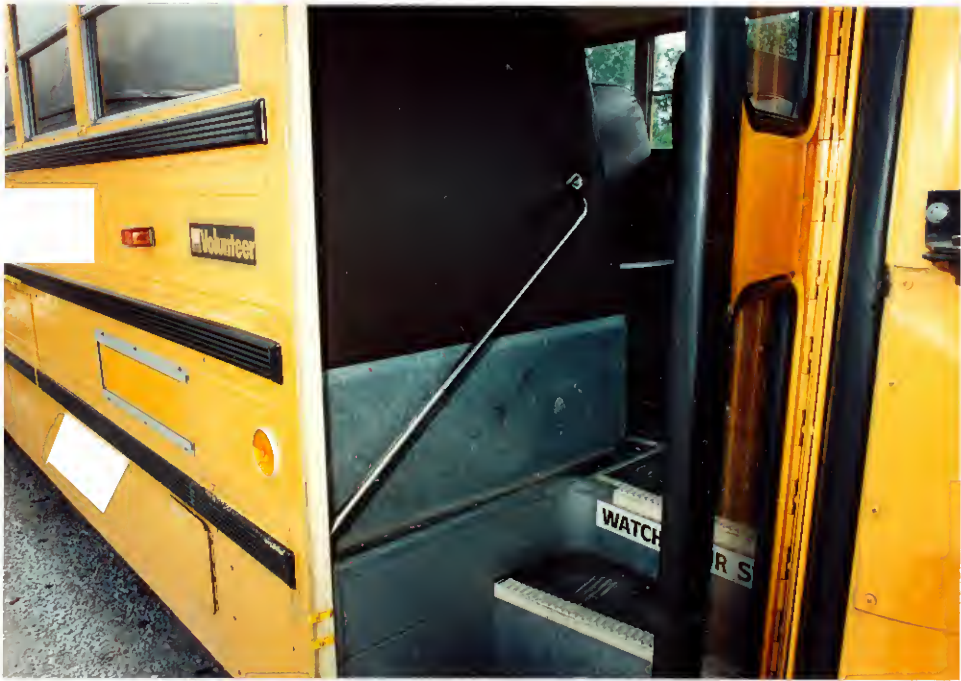
31. Overall view of the stairwell handrail.

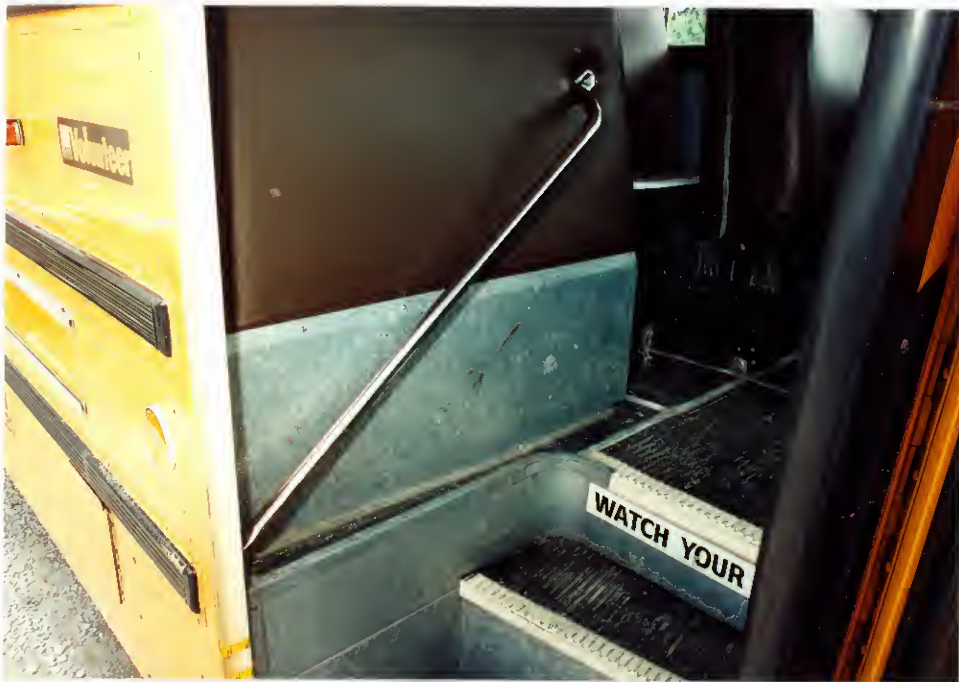
32. Additional view of the handrail.

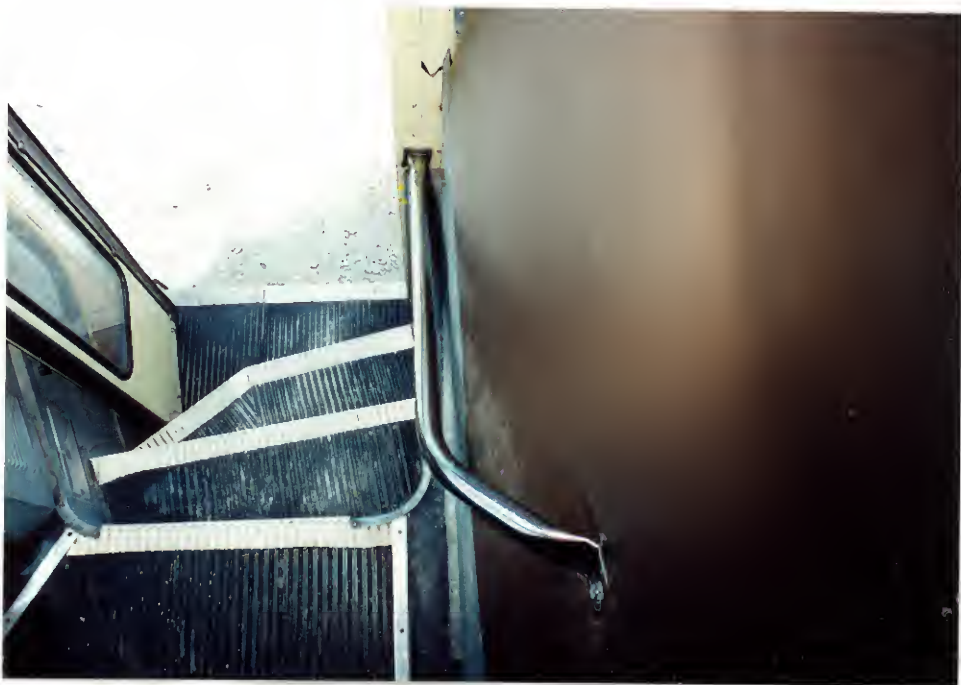
34. Longitudinal view of the handrail.

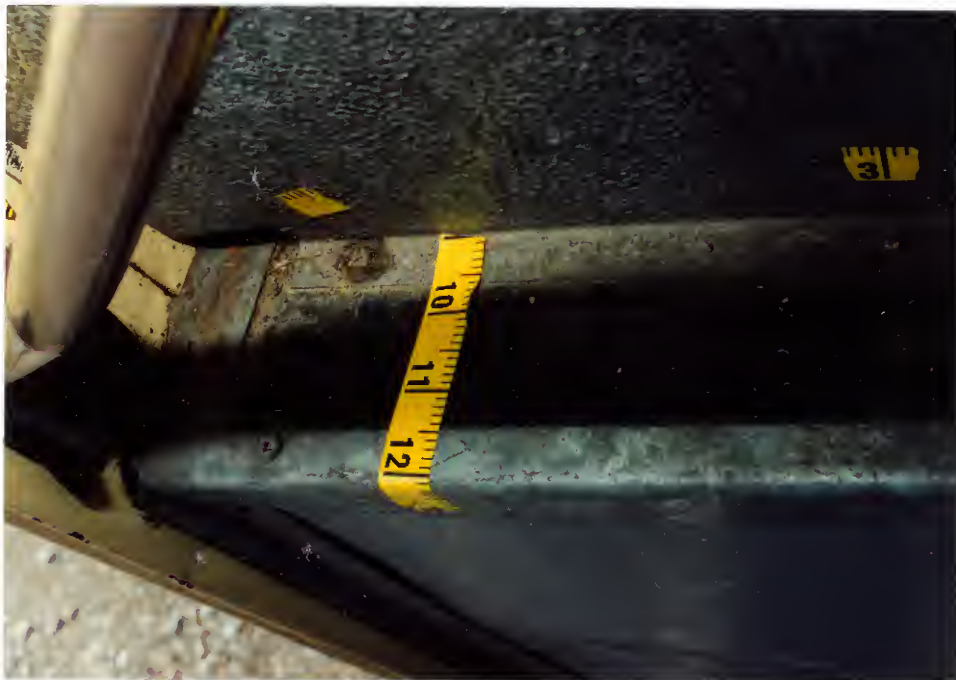
42. Close-up view of the repositioned kick panel at the outboard corner.

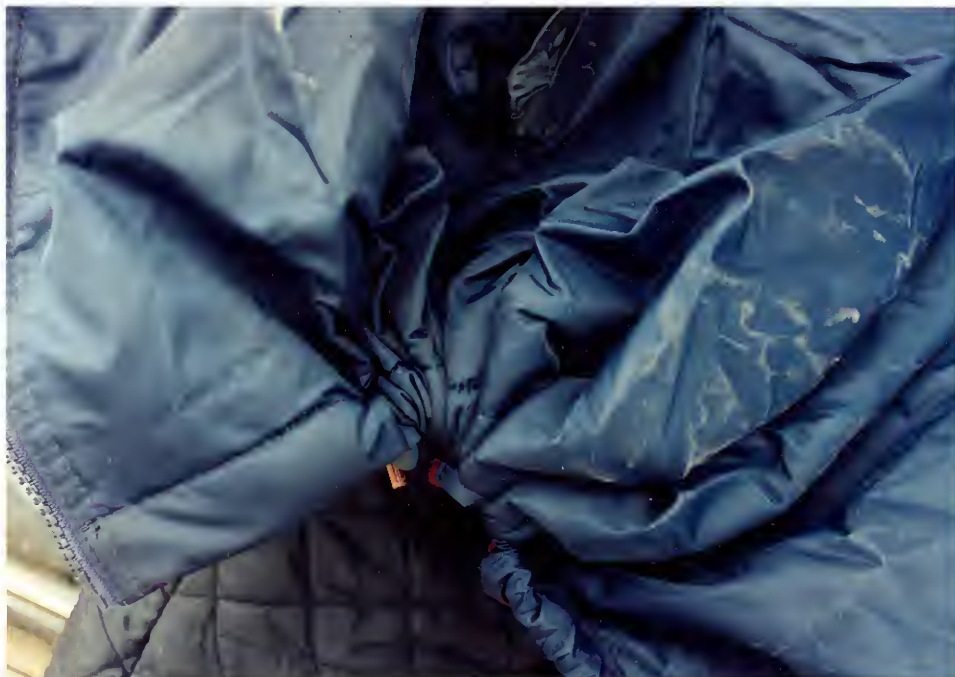
52. Gathered fabric at the left side of the jacket from the pull on the drawstring.

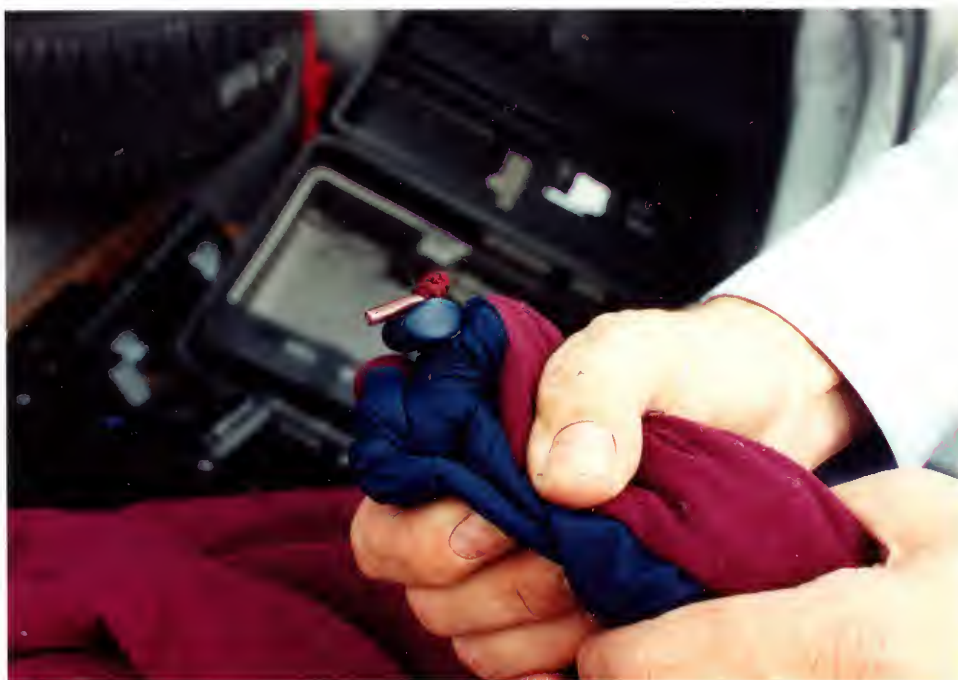
53. & 54. Left side adjustable tab.

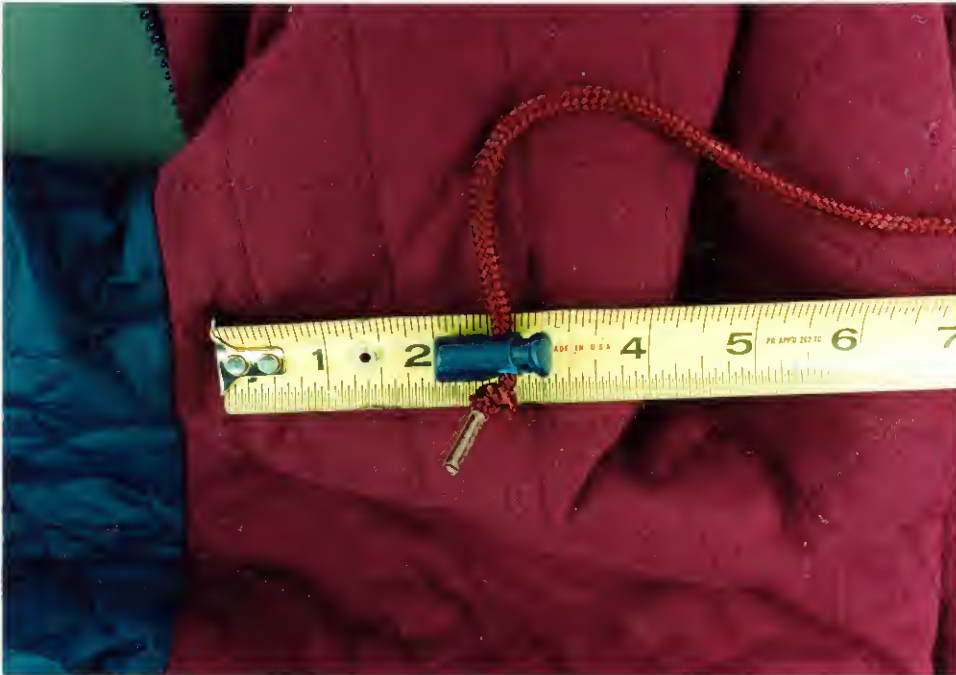
There were two possible components that could have allowed the drawstring to become caught in the bus. The components are the door/V-channel and the base of the handrail. The handrail was ruled out as a possible mechanism by two sources; the bus driver's statement that he observed the jacket (drawstring) fall as he opened the door and the inability to recreate a snagging of the actual drawstring following numerous tests over the handrail configuration. The large tab and the rounded corners on the tab prevented the drawstring from becoming snagged on the rail. The modified foam rubber pad contributed in deflecting the tab away from a possible snag point. Another style of drawstring tab could become snagged between the rail and the previously identified screw hole as documented in Photograph Nos. 44 and 45.

55. Right side adjustable tab which became caught between the door and the V-channel.

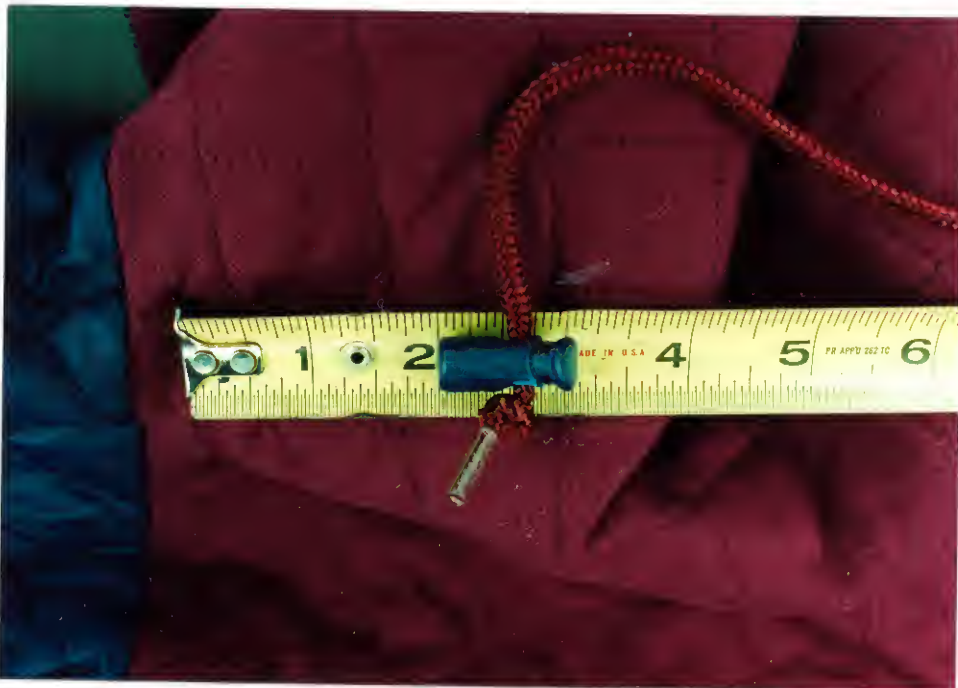
56. Overall length of the adjustable tab (1 1/16").

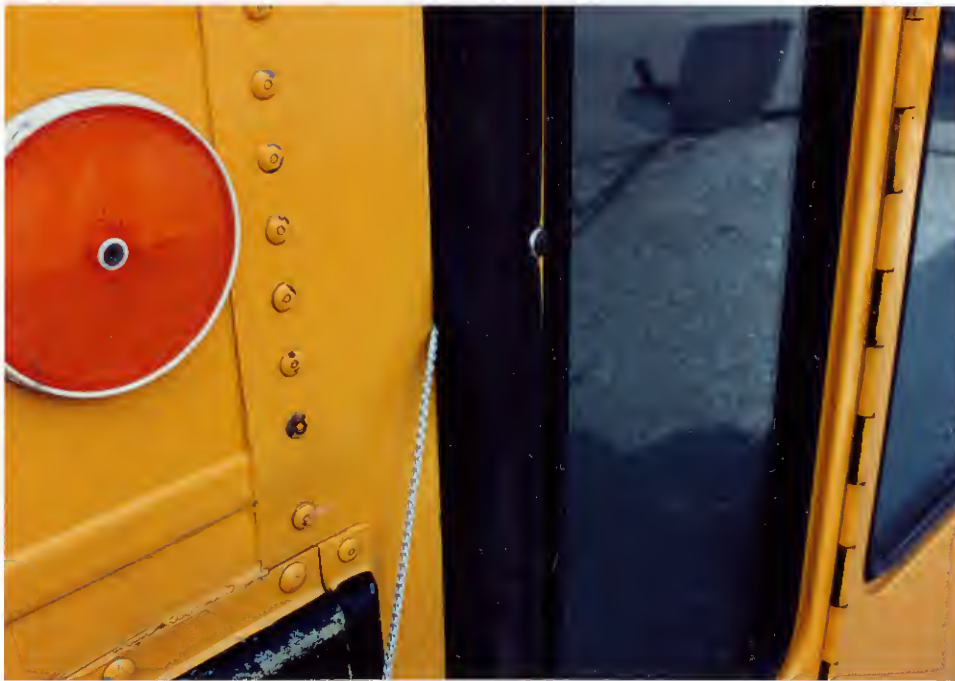
61. & 62. Close-up views of the drawstring tab caught between the door and the V-channel.

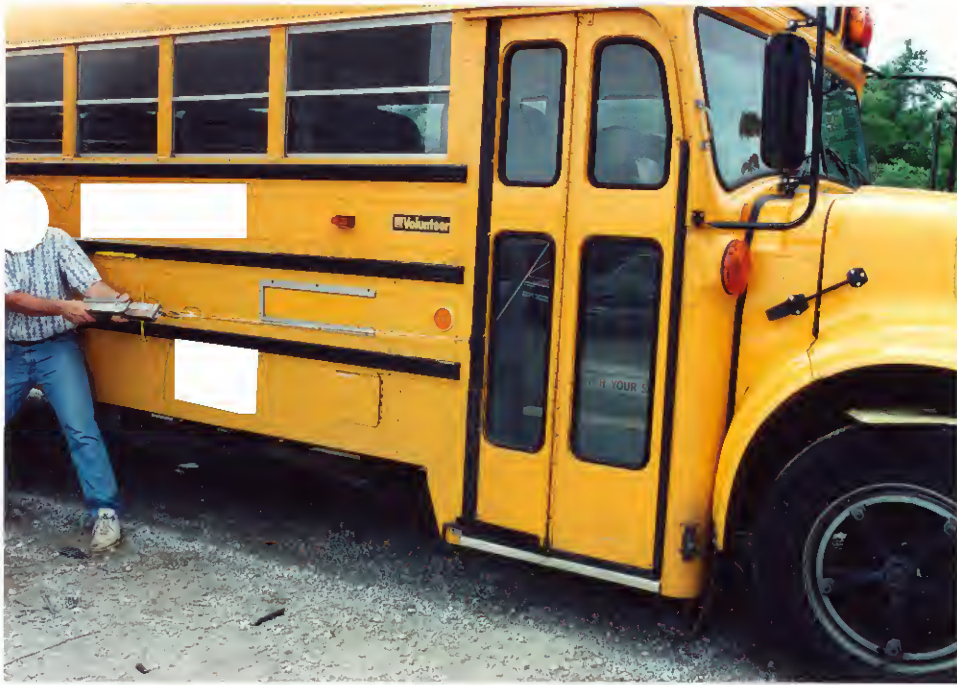
63. & 64. Exterior views of the drawstring extending from the door/V-channel juncture.

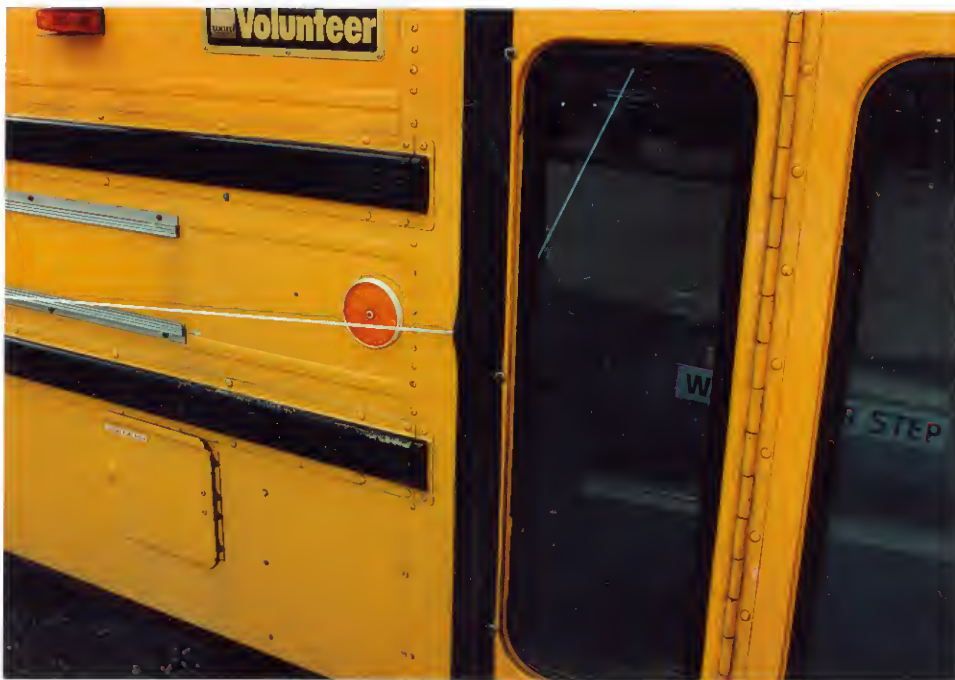
65. Overall view of the pull test using a spring scale to measure the force exerted on an exemplar type drawstring.

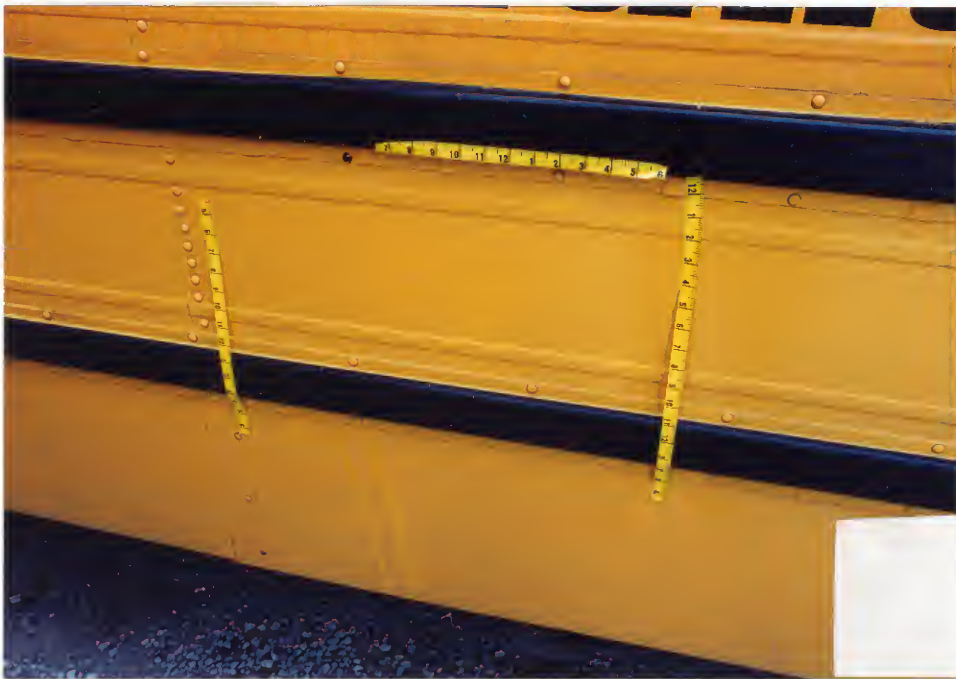
69. Pedestrian's right hand wipe mark on side surface of bus.
Wipe mark was located 74.5-90.25" rearward of the B-pillar.

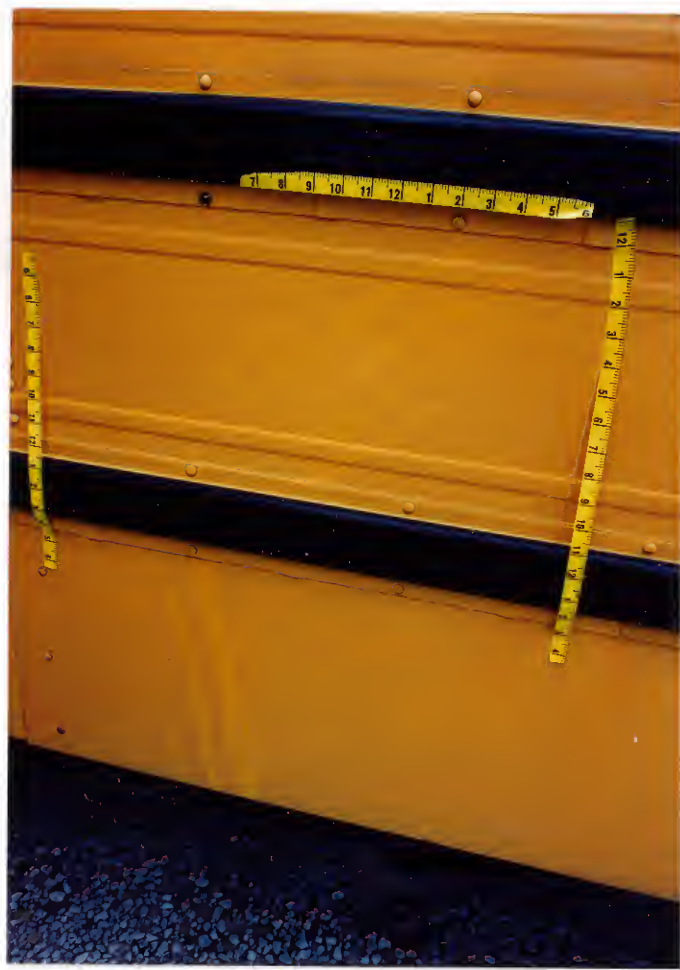
70. Additional view of the pedestrian's right hand wipe mark.

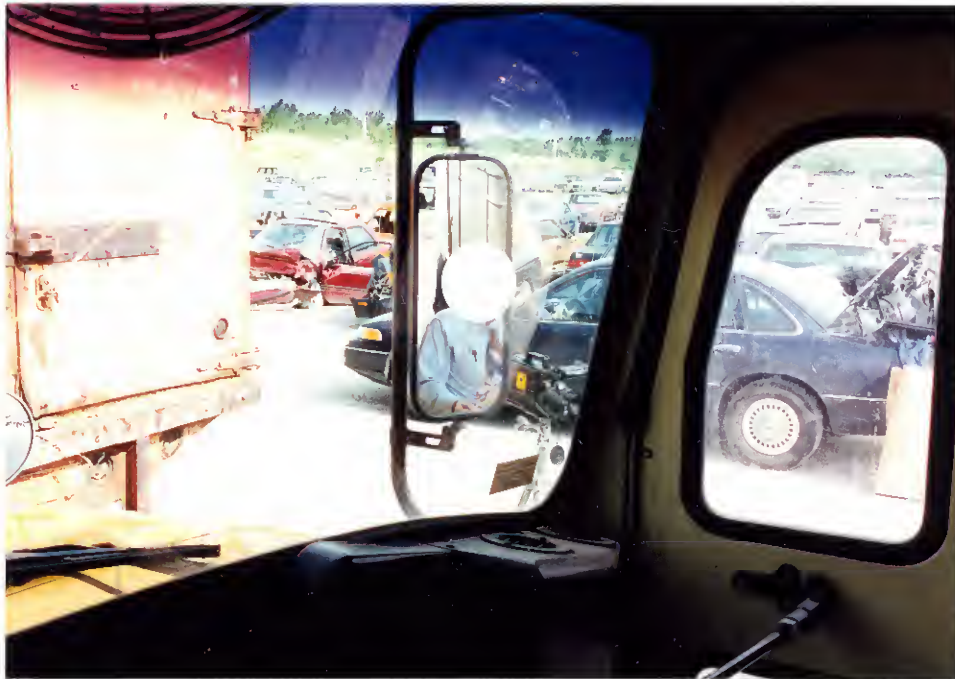
73. Conspicuity of a person standing adjacent to the right B-pillar area of the vehicle in the right convex mirror.
